**ENVIRONMENTAL SURVEY AND ASSESSMENT (REF)
OF
MACS REEF TIP WASTE TRANSFER FACILITY SITE AND
GENERAL TIP SITE.**

**Report prepared
by
Roger Good
Environmental Consultant
Good Environmental Systems
1178 Bungendore Road
Bungendore 2621

FLORA AND FAUNA SURVEY AND ASSESSMENT OF THE WASTE TRANSFER FACILITY DEVELOPMENT SITE AND GENERAL TIP SITE.

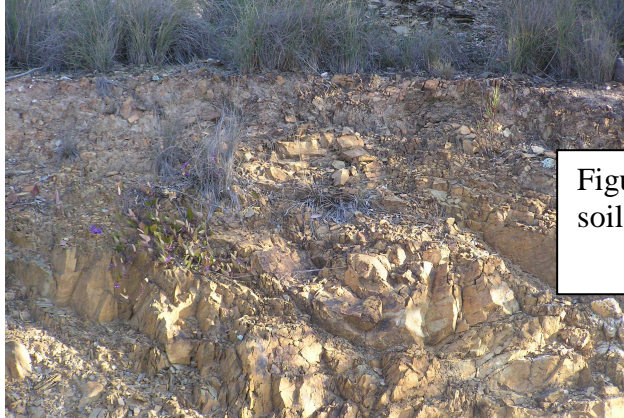
The soils of the general locality have developed from Ordovician metasediments with shales being the dominant bedrock of the along Macs Reef area. The soils are shallow, well drained to poorly drained Rudosols (Lithosols) on the upper slopes with moderately drained Chromosols (Yellow Podzolics) on the mid to lower-slopes (fig 3).

Figure 3. Shallow Brown to Yellow podsolic soils on Ordovician metasediments (shales)

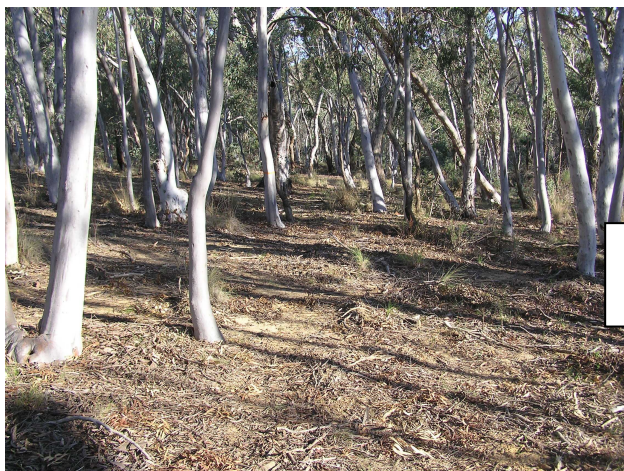
The general vegetation of the area is that of a dry sclerophyll woodland with the overstorey trees being dominated by a mix of eucalypt species, including Brittle Gum *Eucalyptus mannifera*, Scribbly Gum *E. rossii*, Red Stringybark, *E. macrorhyncha*, Long-leaved Box *E. nortonii*, Broad-leaved Peppermint *E. dives* and a sparse and small number of Yellow Box *E. melliodora*. (fig 4) where deeper soils and better soil moisture regimes prevail. Along Macs Reef Road, but at a lower elevation, denser numbers of Blakely's Red Gum *E. blakelyi* and Yellow Box occur.

Figure 4. Dry sclerophyll woodland that dominates the tip site

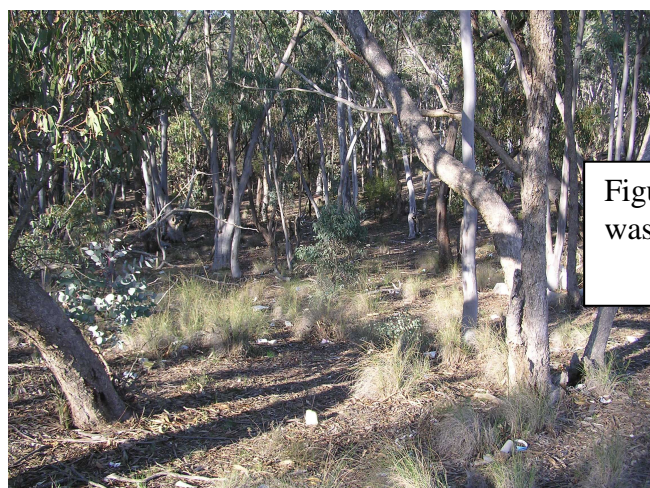
The undisturbed woodland of the site surrounding the actual landfill tip site and that encompassing the proposed waste transfer facility (fig 5), is in a fair to good condition and representative of that which existed over much of the general locality before clearing and domestic stock grazing commenced. The understorey exhibits a sparse representative sample of the understorey sclerophyllous shrubs and native grasses but as with all landfill tips the vegetation has been polluted with waste blown or washed from the tip face. Few weed or exotic plants exist in the undisturbed parts of the site but are extensive in the disturbed parts.

Figure 5. Woodland on the proposed waste transfer facility site

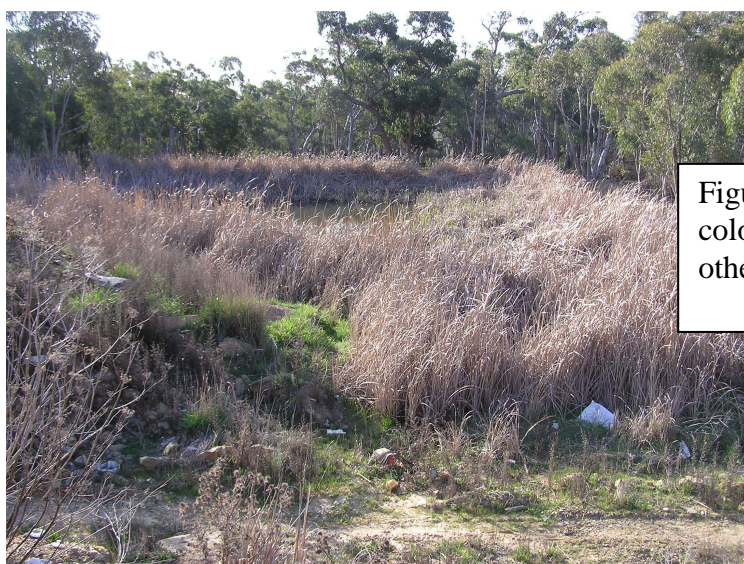
At the lower western side of the tip-face area, a constructed seepage pond has been colonised by Cumbungi *Typha spp.*, Spike Rush *Juncus spp* and *Carex spp*, together with a fringing perimeter of sparse introduced grasses- *Paspalum Paspalum dilatatum*, Brome *Bromus spp*, and *Phalaris Phalaris tuberosa* (fig 6).

Figure 6. Seepage pond colonised by Cumbungi and other emergent aquatic plants.

The small seepage pond near to the proposed waste transfer facility is colonised by aquatic plants and provides good habitat for frogs and other reptiles. This pond should not be back-filled but retained as part of the redevelopment. It could be easily enlarged and be a functional sediment control and settling pond, as well as a landscape and native animal habitat feature of the area.
